**DRAFT FINAL
INTERIM REMEDIAL MEASURES
WORK PLAN
EKCO HOUSEWARES FACILITY
MASSILLON, OHIO**

December 1993

ROY F. WESTON, INC.
1 Weston Way
West Chester, Pennsylvania 19380

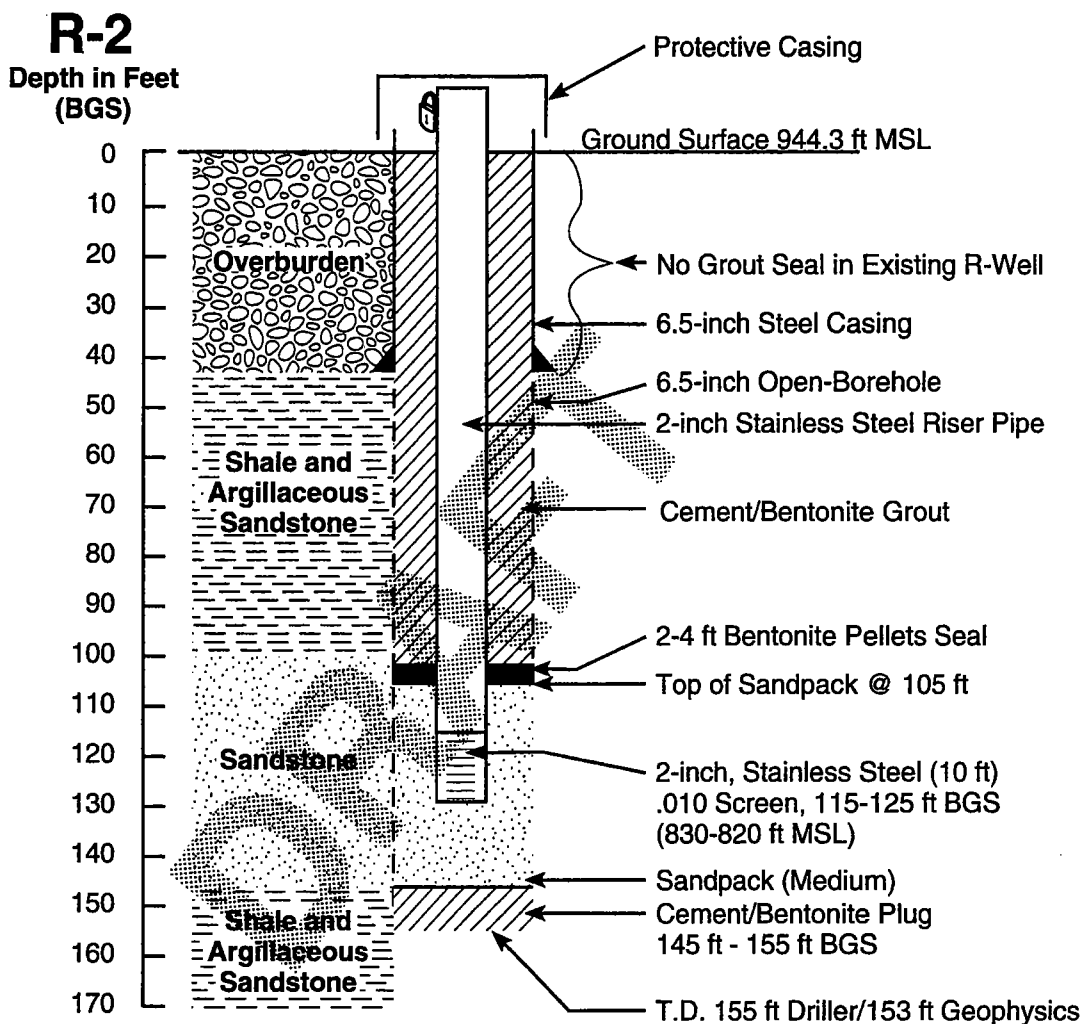
FIGURE 3-3 SCHEMATIC OF PROPOSED CONVERSION FOR WELL R-2, EKCO HOUSEWARES, MASSILLON, OHIO

As part of a packer testing program conducted during the RFI in April 1991, a casing seal test was performed on monitor well R-2. The results of this test indicated that the casing seal was leaking and allowing shallow aquifer groundwater to enter the well and migrate downward into the open borehole section of the well. Additionally, the packer testing results in the open borehole portions of wells R-1, R-2, and R-4 indicated that a downward hydraulic gradient existed in each of these wells, a finding consistent with the sitewide bedrock geology. The problems associated with leaking or deteriorated bedrock well casings at the site are as follows:

The rehabilitation approach for the R-wells is to retrofit or convert each of the wells from 6-inch-diameter open bedrock wells, to 2-inch-diameter screened bedrock wells. Currently these wells are used for quarterly groundwater monitoring. Each well would be screened from approximately 115 to 125 ft below ground surface (BGS) and sandpacked to approximately 10 ft above the top of the screen. A bentonite seal would be emplaced above the sandpack and a cement/bentonite slurry tremie-grouted from the top of the bentonite seal to ground surface. The thick cement/bentonite seal across the argillaceous sandstones

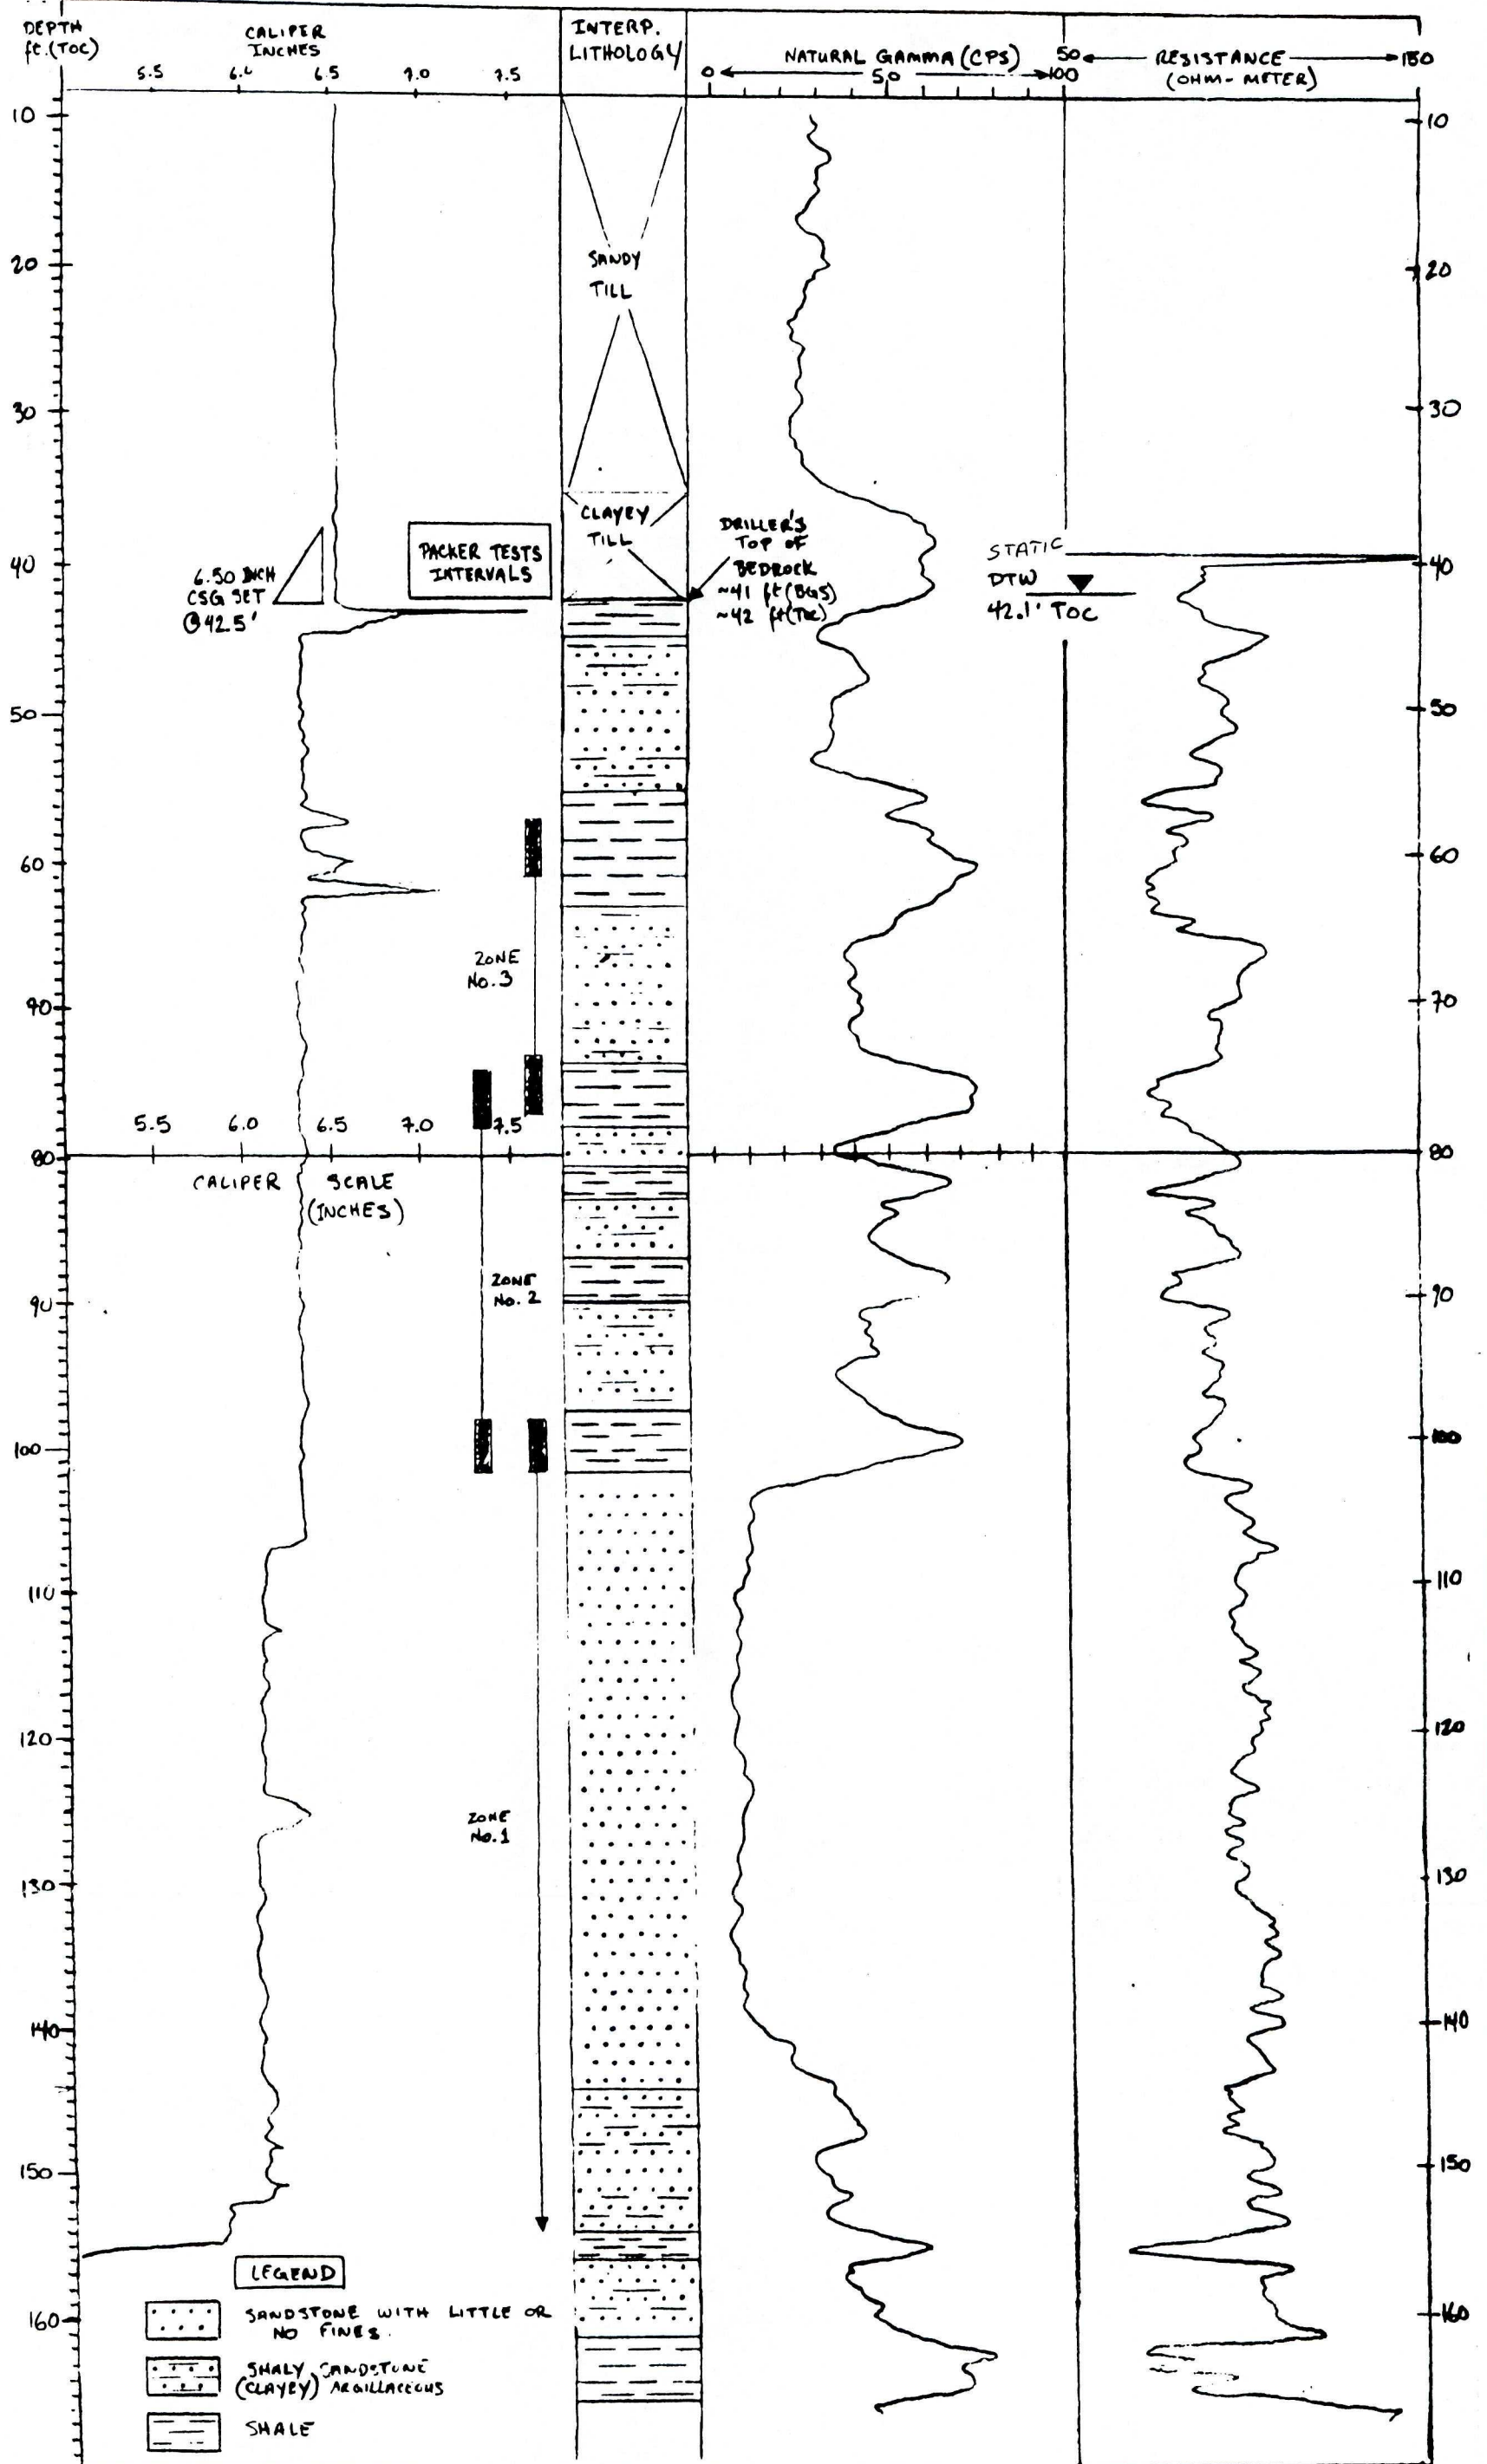
Figure 3-1: Packer Test Intervals, Geological and Geophysical Logs for Monitor Well R-1

The shale beds in wells R-1 and R-2 are indicated on the logs by relatively high gamma response (50-70 cps) and correspondingly low electrical resistance. Shales are by definition low in permeability unless secondary fracturing has occurred. The sedimentary rocks in the region of the site have not undergone any appreciable deformation and, in fact, dip only slightly to the southeast (USGS).
